ANALYSIS OF WEATHERED c-Si PV MODULES

D. Chianese, A. Realini, N. Cereghetti, S. Rezzonico, E. Burà, G. Friesen, A. Bernasconi
LEEE-TISO, University of Applied Sciences of Southern Switzerland (SUPSI), DCT
Via Trevano, 6952 Canobbio, Switzerland
Phone: +41/91/935 13 56, Fax: +41/91/935 13 49, www.lee.dct.supsi.ch

ABSTRACT

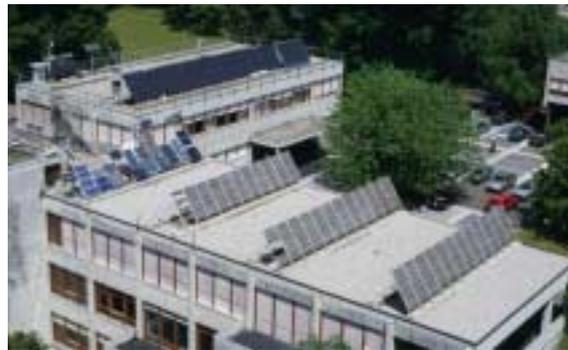
Figure 1: Test stand of the LEEE-TISO testing centre (left) and the TISO 10kWp grid-connected PV power plant (right).

In the test stand (see Figure 1), the modules were selected from those most commonly found on the Swiss market or which had interesting innovations. In order to guarantee impartiality and neutrality regarding measurements, the modules were purchased anonymously. Two modules for each type were acquired.

In May 1982, the first European grid-connected PV plant came into operation (see Figure 1). The first objective of this array was to provide a technologically advanced facility of medium size, giving practical information for the planning of future photovoltaic plants.

The plant consists of 288 Arco Solar ASI 16-2300 modules distributed in 3 sub-arrays of 12 horizontal per 8 verticals panels each (see Figure 1). Since the plant realization in 1982, the system configuration has been changed three times because of inverters substitutions. At the beginning the plant was organised in 24 series of 12 modules each; at present there are 12 series of 21 modules. In the near future, the inverter unit will be substitute and the new plant configuration will consist of 12 series of 24 modules each.

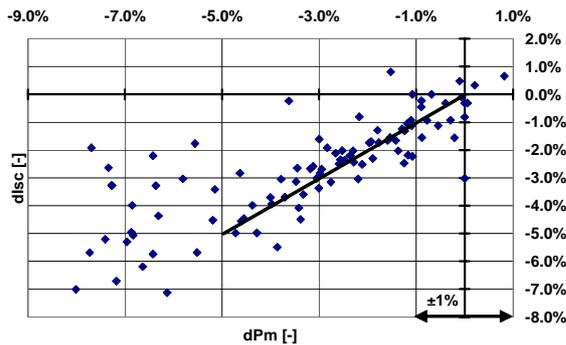
Figure 2: degradation of I_{sc} vs. degradation of P_m after 3 months of exposure, for 98 c-Si modules (1997-2003).

In order to avoid first degradation effects influences the determination of module energy yield, the test procedure of the LEEE-TISO laboratory, has been modified in 2001 adding a period of light soaking of 20kWh/m² followed by 3 months of stabilisation [1]. In this first outdoor exposure period the mean degradation of the 98 c-Si modules tested at the LEEE-TISO is -3.0%. The degradation is between -0% and -5% with respect to the initial power P_a [1]. The performance loss is mainly due to degradation of the short circuit current I_{sc} (see

Figure 2). Considering the measurement precision, for degradations up to -5% a linear relation between power and I_{sc} degradation can be observed. Modules with a larger degradation (>5%) shows no direct correlation with I_{sc} , they seems to be influenced by other factors as the open circuit voltage V_{oc} or the fill factor FF (Figure 3 and 4). In the last two tests cycles (8 and 9 i.e. 2001-2003) the measured mean degradation was -1.9%, ranging from -5.2% to +0.1%.

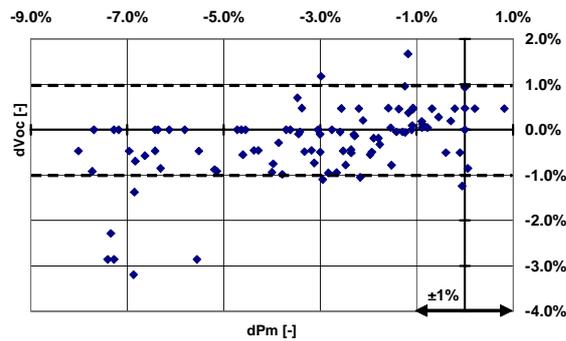
Figure 3: degradation of V_{oc} vs. degradation of P_m after 3 months of exposure, for 98 c-Si modules (1997-2003).

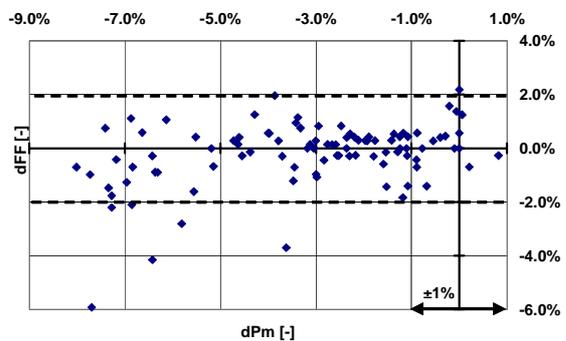
Figure 4: degradation of FF vs. degradation of P_m after 3 months of exposure, for 98 c-Si modules (1997-2003).

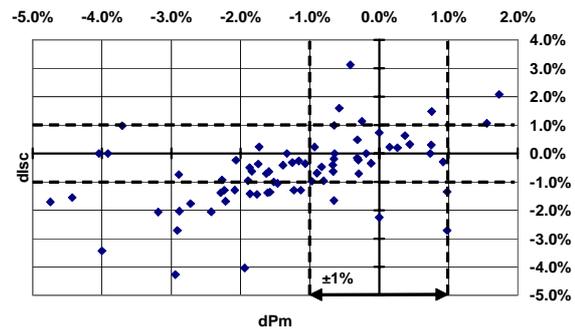
Figure 5: degradation of I_{sc} vs. degradation of P_m after 1 year of exposure, for 76 c-Si modules (1997-2002).

During the first year of outdoor exposure under real climatic conditions and after the initial degradation, the weathered modules shows a further average degradation of -1.2%. The relative average degradation of the short circuit current was -0.6%, of the open circuit voltage -0.2% and of the fill factor -0.4%.

Even if the reproducibility limit of the measurements does not permit to see a real degradation in I_{sc} , V_{oc} or FF, the negative trend of P_{max} is slightly larger than the measurement uncertainty (Figure 5, 6 and 7).

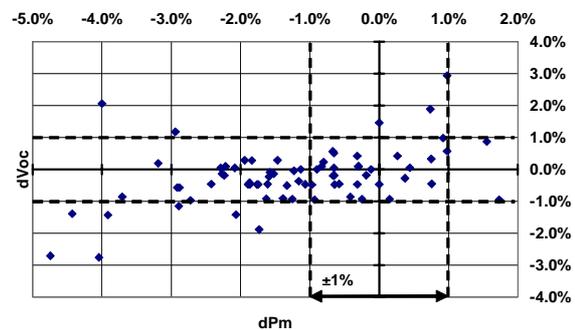
Figure 6: degradation of V_{oc} vs. degradation of P_m after 1 year of exposure, for 76 c-Si modules (1997-2002).

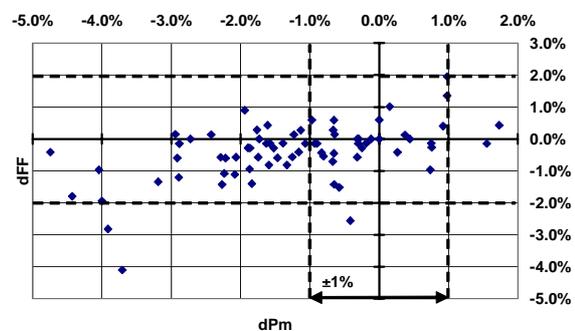
Figure 7: degradation of FF vs. degradation of P_m after 1 year of exposure, for 76 c-Si modules (1997-2002).

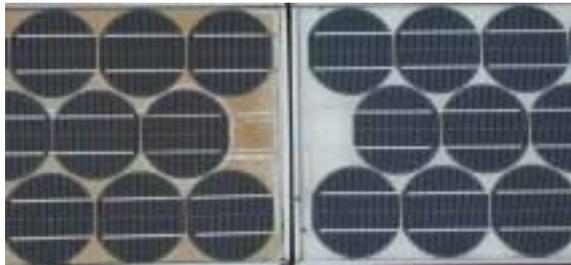
Figure 8: 21-year old module ASI16-2300 (ARCO Solar Inc.).

The ASI 16-2300 are sc-Si modules with 35 round cells (\varnothing 102.5mm), using PVB (poly-vinyl-butryal) encapsulant and tedlar/aluminium/tedlar backsheet.

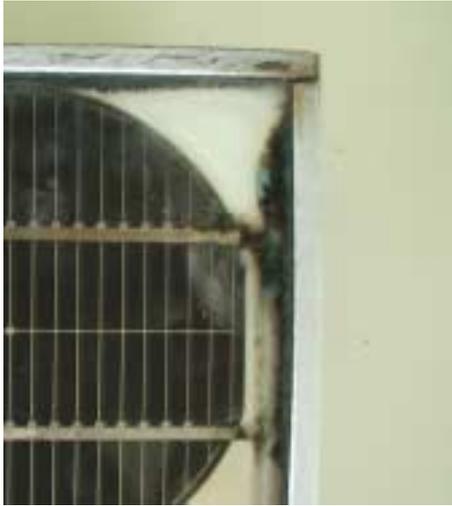
Figure 9: water penetration corresponding to the tedlar backsheet detachment in a 21-year old ASI16-2300 module.

After one year, in October 2002, the backsheet detachment in the bottom part of two naturally aged modules (0.8% of the plant) has been detected. At present, this phenomena affects 31 modules (12.3% of the plant - +11.5% after 7 months). Even if tedlar is still attached along the edges, the eventual exposition of the aluminium foil has to be kept under control, as it could represent an electrical safety hazard. For the moment, modules with such a defect do not present power degradation.

One of the major disadvantages of PVB as a module encapsulant was its propensity for water absorption, which complicated handling procedures and occasionally produced voids on lamination. Moisture sensitivity dictated the use of a metal foil backsheets, as was made for ASI 16-2300 modules. Such a precaution did not prevent PVB delamination; since 1986, the presence of water infiltration and sealant penetration in some modules was documented [3]. At present, 233 modules (92% of the actual plant) show encapsulant delamination along edges and 191 (76% of the actual plant) sealant diffusion.

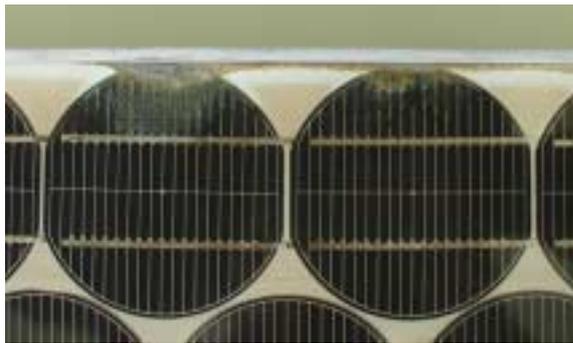
Figure 10: Delamination affecting cells nr. 5 and 6 of the ASI16-2300 module A005.

One of the plant modules (AA005) presenting several differently delaminated cells has been subjected to repeated visual inspection and performance measurements. During three years, the progressive electric degradation related to the cells deterioration has been detected.

Electrical characterization of differently delaminated cells showed that performance losses of single cells are proportional to their affected area [1]; the Fill Factor decrease show the effects on series resistance R_s .

Cells delamination also affects the overall module efficiency, but it involves different parameters. In the last three years, the module power degradation has been equal to -2.5%, while the power loss of the cells affected by delamination has been -3.8% (Table I and II). While for single cells, delamination affects the short-circuit current I_{sc} and the Fill Factor, for the overall module only the Fill Factor FF shows a decrease (Table II).

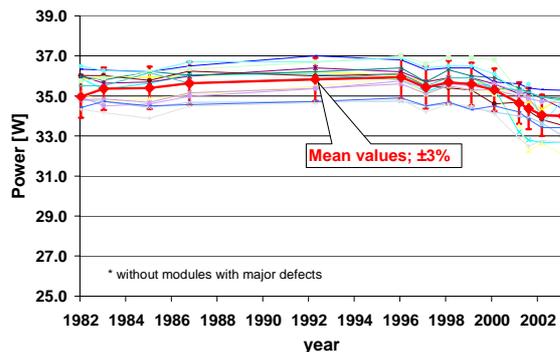
Figure 10: Power (STC) evolution of 18 reference modules during 21 years of outdoor exposure.

Figure 10 shows the performance behaviour of 18 reference modules of the 10 kWp TISO plant. In the last 5 years, a slight power degradation occurred. The difference between the power measured in 1982 and the one obtained in 2003 is equal to about -3%. This result is confirmed by the data from outdoor measurements results. However, such a result does not allow to determine the modules long-term stability, due to changes in the measurement system during 20 years.
